Method for testing modern common rail piezoelectric fuel injectors

The paper presents the author's own method for testing piezoelectric common rail fuel injectors, which for many years were considered non-repairable components. This was mainly due to the lack of availability of spare parts and dedicated measuring equipment, enabling full diagnostics under test bench conditions. As a result, their workshop and laboratory servicing was very limited, as effective disassembly concerned basically only the plunger and barrel assembly (needle with nozzle) for selected reference models. The situation has now improved to such an extent that an author's own regeneration procedure has been proposed with the replacement of the most important controls and actuators. The tests were carried out on the example of Siemens VDO Continental PCR 2.3 fuel injectors from one engine, listing the most important stages of this process, including the correction of fuel dosage and returns.

The tests were carried out on the Siemens VDO Continental 2.3 PCR fuel injectors, the set of which was dismantled from the 2.0 TDCi (Turbo Diesel Common Rail Injection) engine of a Ford C-Max vehicle with an operational m

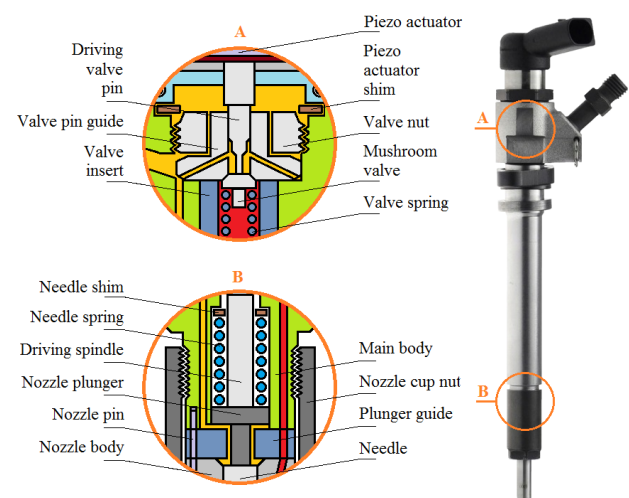
Fig. 1. Siemens VDO Continental PCR 2.3 fuel injector design

This type of fuel injectors operate at injection pressures not exceeding 160 MPa [20]. A characteristic feature of their construction is the piezoelectric actuator, which is screwed to the upper part of the main body with a nut (Fig. 1). As the same assembly occurs in most solenoid-controlled solutions, with the exception of Delphi products [19], hence the term “coil” has become popular in colloquial speech. It is convenient from the practical side, as it allows for trouble-free replacement of the crystal stack in case of damage and the calibration process.

gard, the method of adjustment, which was carried out during assembly, played a key role. The Mega Tester V3 tester, while sending the test signal, measured the GAP parameter on an ongoing basis, which enabled the assessment of the applied torque. Failure to control this process could result in improper pressure of the crystal stack on the valve plunger and a disturbed response of the mushroom valve opening the borehole that connects the control chamber with the fuel return (Fig. 1).

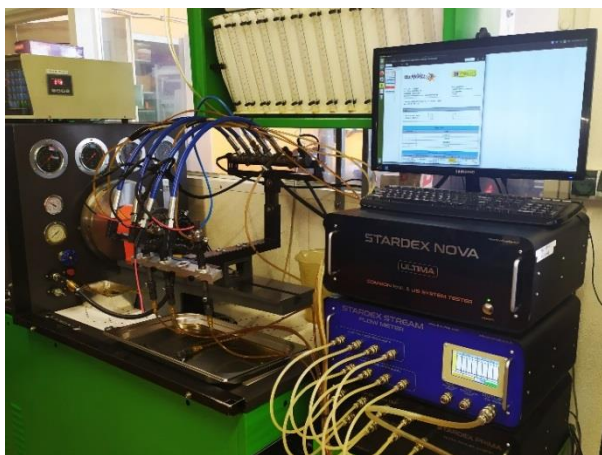
- 12PSB test bench equipped with a Stardex test kit, including the Nova Ultima simulator, Stream flowmeter and Prima cooling, filtering and damping system (Fig. 2),
- Mega Tester V3 piezoelectric actuator tester,
- Yizhan 13MP HDMI VGA industrial microscope camera,
- IP54 electronic micrometer,
- ultrasonic cleaners (Polsonic Sonic 9, Bene YesWeCan 3l),
- vices, grips and tools for assembling and disassembling fuel injectors.

Fig. 2. 12PSB test bench with Stardex kit

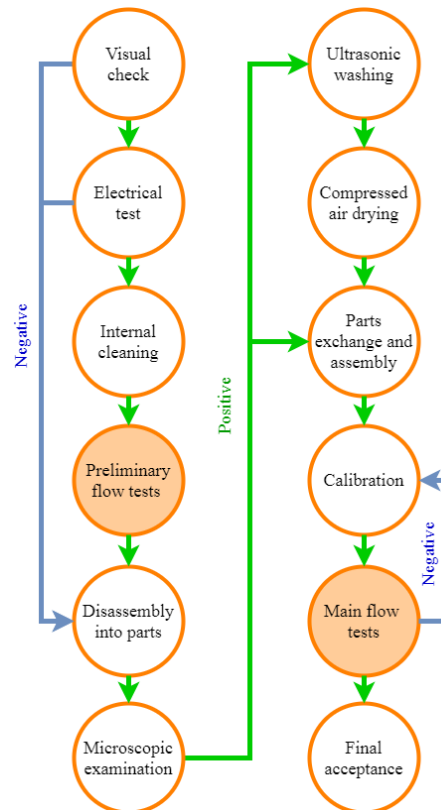
Figure 3 shows a test plan which only partially overlaps with the procedures specified by Siemens VDO Continental. Thanks to the available equipment, it is possible to detect a piezoelectric actuator failure in the initial phase, which excludes a given fuel injector from thermochemical cleaning and preliminary flow measurements on the test bench. In addition, with the operational mileage over 200,000 km, it is assumed from the top down that the needle and sprayer should be replaced, similarly as is the case with other manufacturers [18]. As a result, visual inspection of the injected fuel stream does not require an additional stage and is performed during test-bench tests. According to the adopted methodology, the microscopic inspection of the plunger and barrel assembly is carried out optionally, primarily in order to detect metallic filings from a faulty

pump. Therefore, cleaning in ultrasonic cleaners follows this test and only covers components that will not be replaced. Final acceptance is preceded by the phase of calibration and main tests, repeated when incorrect results of fuel dosing are obtained.

Fig. 3. Research plan

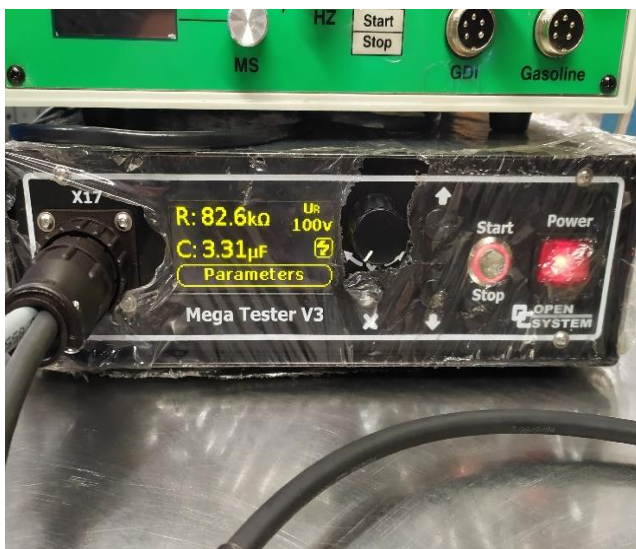
In the fuel injector No. 3, the resistance value was outside the limits recommended by the manufacturer, i.e. 160–220 kΩ [21]. Moreover, the failure status was signalled on the reading screen with the lightning bolt symbol, which means internal short circuit condition (Fig. 4). In turn, the fuel injector No. 4 was characterised by too low capacity of the crystal stack, which fell below the permissible value of 2.8 μF, and additionally a negative result was obtained in the continuous load R_C test (Fig. 5). As a result, a decision was made to exclude these fuel injectors from the initial flow measurements on the test bench.

Fig. 4. Failure of the piezoelectric actuator (fuel injector No. 3)

The organoleptic examination and high magnification revealed numerous traces of corrosion on the components that had contact with the fuel (Figs 7, 8). Due to the frictional wear of the working surfaces, it was decided to replace the sets of nozzles, valve assemblies and drive plungers. New piezoelectric actuators were also used, and the remaining components were bathed in ultrasonic cleaners.

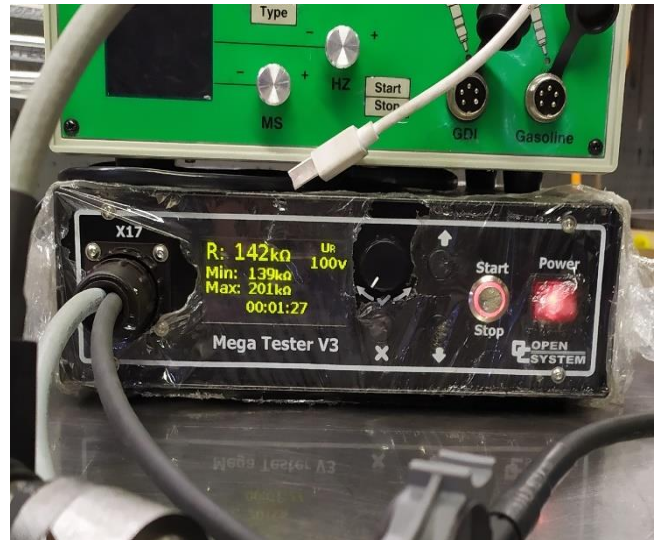
Fig. 5. Negative result of the measurement in the continuous load test

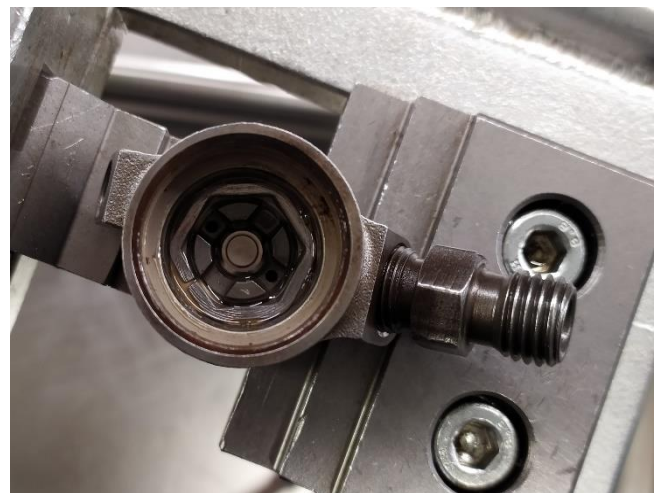
However, it would be premature to make a conclusion about the presence of persistent pollutants, as the fuel injectors underwent a half-hour thermochemical cleaning procedure. It is carried out at a high temperature of detergent in order to dissolve and flush existing deposits. Besides, damage to the valve assembly is affected by various factors, such as destructive erosion and cavitation processes within the valve seat [7]. Therefore, in accordance with the proposed own methodology, the disassembly phase was carried out (Fig. 6).

Rys. 6. Fuel injector after disassembling the piezoelectric actuator

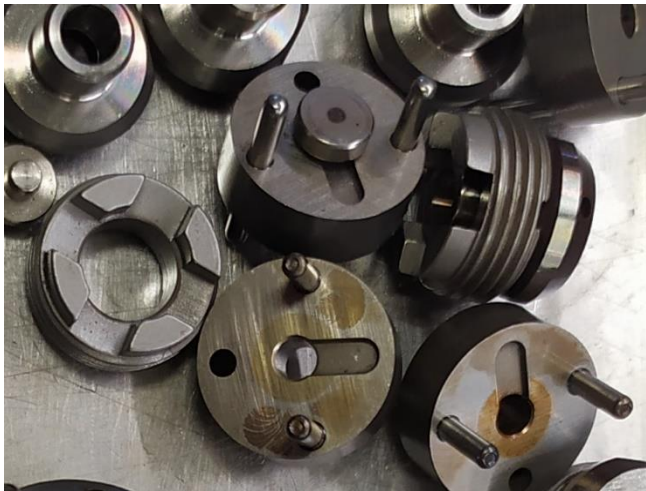
Fig. 7. Disassembled nozzle plunger guides and valve assemblies

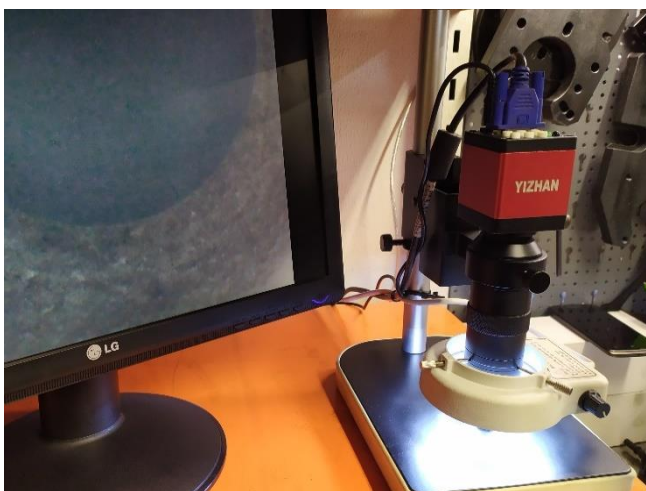
Fig. 8. Examination of the valve seat on a microscope stand

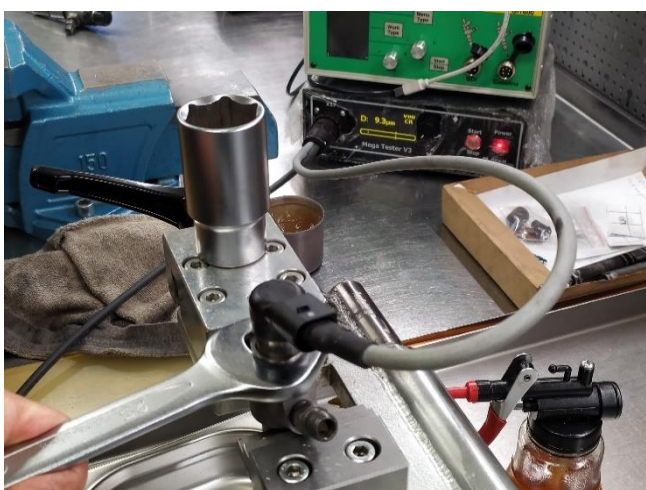
The results of the research presented in the publication [12] indicate that with the temperature increase, the capacity of the crystal stack increases in accordance with the logarithmic dependence. The distance between the actuator and the valve tappet thus compensates for the effect of thermal expansion, but the gap size is additionally affected by the degree of polarisation of the piezoelectric elements. Therefore, the regulation should be performed at room temperature, eliminating the influence of too high or negative stack voltage [14]. Due to the underestimated dosing method in the preliminary test, the GAP parameter was reduced to 4 μm in all fuel injectors (Fig. 9). As the maximum tightening torque of the actuator is 20±5 Nm, hence shims from the lower selection group were measured and selected prior to assembly (Fig. 10).

Fig. 9. GAP regulation using the Mega Tester V3 tester

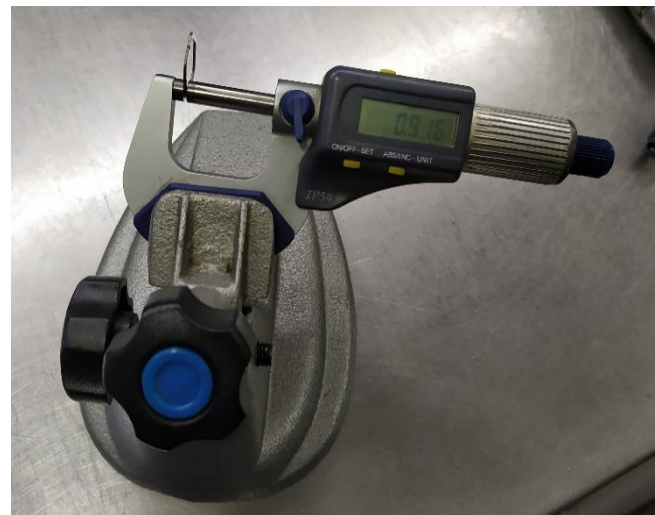
Fig. 10. Measurement of the thickness of the actuator shim
