Issues in the conservation and restoration of powertrains as engineering art monuments

The article discusses issues related to the behavior of powertrains understood as monuments of engineering art. The theoretical part analyzed the most important issues related to the maintenance and renovation of vehicles, their share in Poland in the age category, as well as the regulations regarding the classification of historic vehicles. The next part of the article presents the renovation process of two powertrains – the K-750 motorcycle and the Volkswagen Type 117 passenger car, along with a short production history. Then, recommended procedures for unique objects were discussed in the context of their state of preservation and occurrence based on the authors' experience.

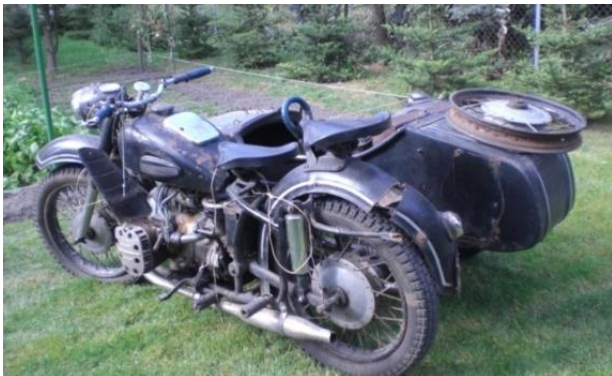
Fig. 1. Object undergoing renovation: K-750 motorcycle produced in Kiev in 1962

The subject of the renovation was a two-cylinder boxer combustion engine, Soviet production, with a displacement of 750 cm³ (Table 2). It was used to power motorcycles M-72, MW-750, K-750, and all their varieties from factories in Moscow, Irbit, and the Urals (Fig. 1). The engine design was taken from the German BMW R-71 military motorcycle in 1939. Due to its use, the engine had to be characterized by high durability and power because it powered a machine equipped with a sidecar, where the total weight of the vehicle, including equipment and weapons, exceeded 450 kg (Fig. 2). After the war, the production of motorcycle harnesses was not discontinued; their design was slightly changed to make them more suitable for urban driving, for example, the gear ratios in the gearbox were changed.

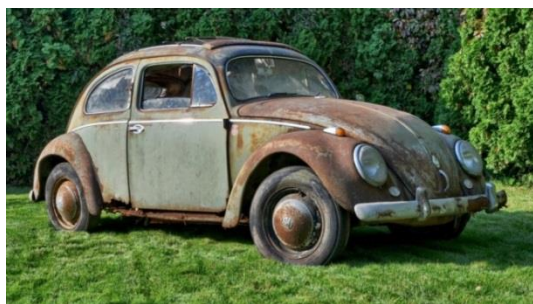
Fig. 3. Object undergoing renovation: Volkswagen Type 117 car produced in Wolfsburg in 1954

Another object undergoing renovation was a four-cylinder boxer combustion engine, made in Germany, with a displacement of 1,192 cm³ (Table 3, Fig. 3). Its history began in 1934, when Ferdinand Porsche began design work on a vehicle intended to motorize post-war Germany. Unfortunately, the ambitious plans were interrupted by the outbreak of World War II, during which most of the units produced were used for military vehicles, such as the 4-seater Kübelwagen light off-road vehicle or the Schimmwagen floating all-wheel drive vehicle, as well as for power generators. After World War II, the engine was used in vehicles such as the Volkswagen Type 1 "Beetle", Type 2 "Transporter" and Type 14 "Karmann-Ghia" [7]. The latter, based on the "Beetle" chassis, had a special, sports body manufactured at the plant in Osnabrück. In the following years, this unit underwent several modifications aimed at improving efficiency. The most important changes included: the addition of a Bosch L-Jetronic injection system with electronic control in 1974 and the introduction of a liquid cooling system in 1982, used in the third-generation Transporter model [3].

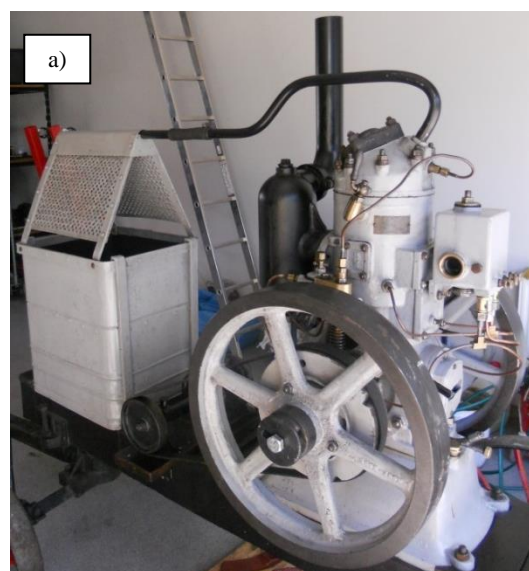
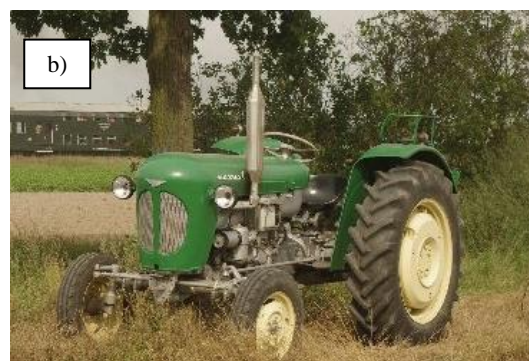
Fig. 5. Unique monuments of engineering art in the collections of the National Museum of Agriculture and Food Industry in Szreniawa: a) Motor Polski produced in Żnin in 1930, b) Ursus C-342 produced in Warsaw in 1965

Based on the authors' experience and in consultation with conservators, certain guidelines for the protection of unique objects have been formulated (Fig. 5). During conservation work carried out by both enthusiasts and conservators, it is very important to create documentation of the progress of the work. This not only has a positive impact on

When referring to monuments of engineering art, unique in their existence or related to historical figures, the conservation process and possible renovation should be considered individually. For objects in a poor state of preservation, renovation means replacing most of the parts with new ones. In such a case, a better solution is to preserve the remnant and create a vehicle modeled on what remains of its original structure. Operation (even for demonstration purposes) is also not recommended for unique objects because each start-up of, e.g., a heat engine, involves its destruction. Examples of such objects that require special conservation care include a two-stroke stationary engine manufactured by "Motor Polski" from Żnin (1930, Fig. 5a), the prototype Ursus C-342 (1965, Fig. 5b), or the concept Polish car FSM Beskid. All objects have been preserved in fewer than 10 pieces, which makes them unique in the world. They are all in museums.
